Mercedes-Benz Vito

General Information	
Seller Name	Hein Wunna Hlaing
Engine Capacity	3500 CC
Mileage	48934 Km
Fuel Type	Petrol
Transmission Type	Auto
Color	White
Location	Mayangone

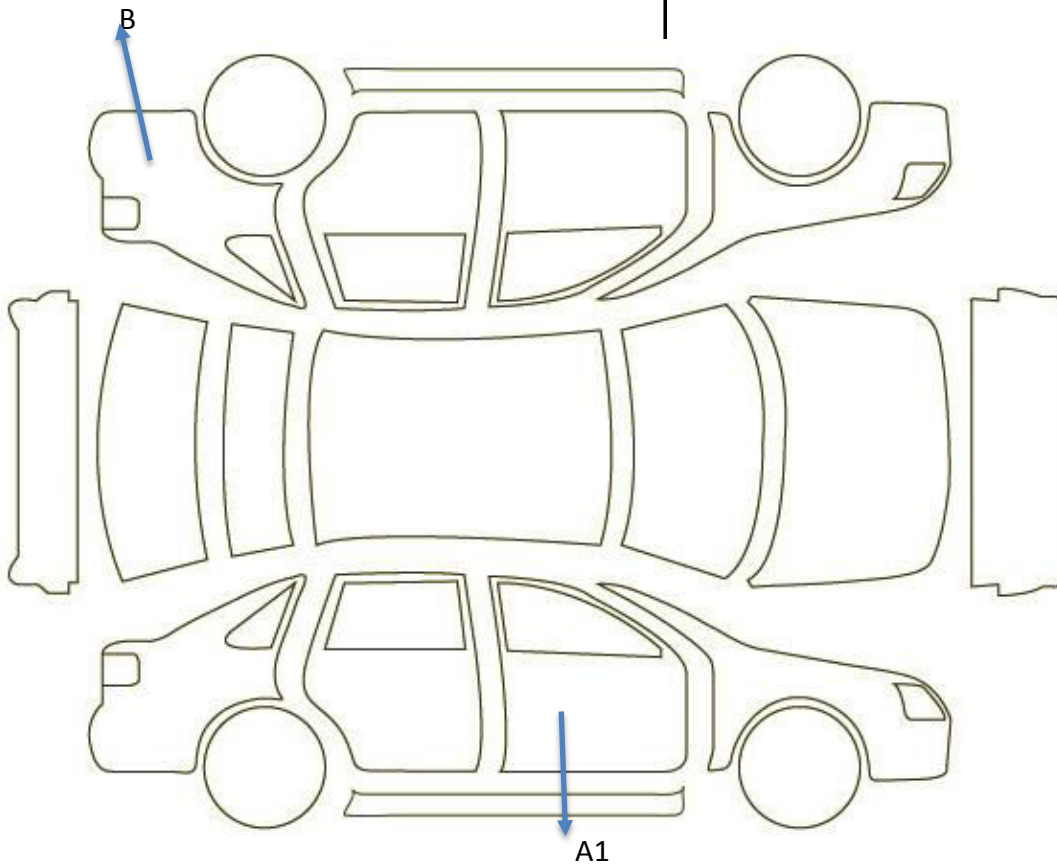
Tyres		
Brand Name		Front Right-Bridgstone/Front Left-Continental/Rear Left-Continental/Rear Right-Hifly
Tyre Size	17	
Front Right	2	6% Tyre Life Remaining
Front Left	2	6% Tyre Life Remaining
Rear Right	2	6% Tyre Life Remaining
Rear Left	2	6% Tyre Life Remaining
Spare Tyre	Ok	
Rims	Ok	
Exterior Condition
