<b>Toyota Succeed</b>
-----------------------

General Information	
<b>Seller Name</b>	Aung Aung Oo
<b>Engine Capacity</b>	1500 CC
<b>Mileage</b>	171786 Km
<b>Fuel Type</b>	Petrol
<b>Transmission Type</b>	Auto
<b>Color</b>	White
<b>Location</b>	Mingalartaungnyunt

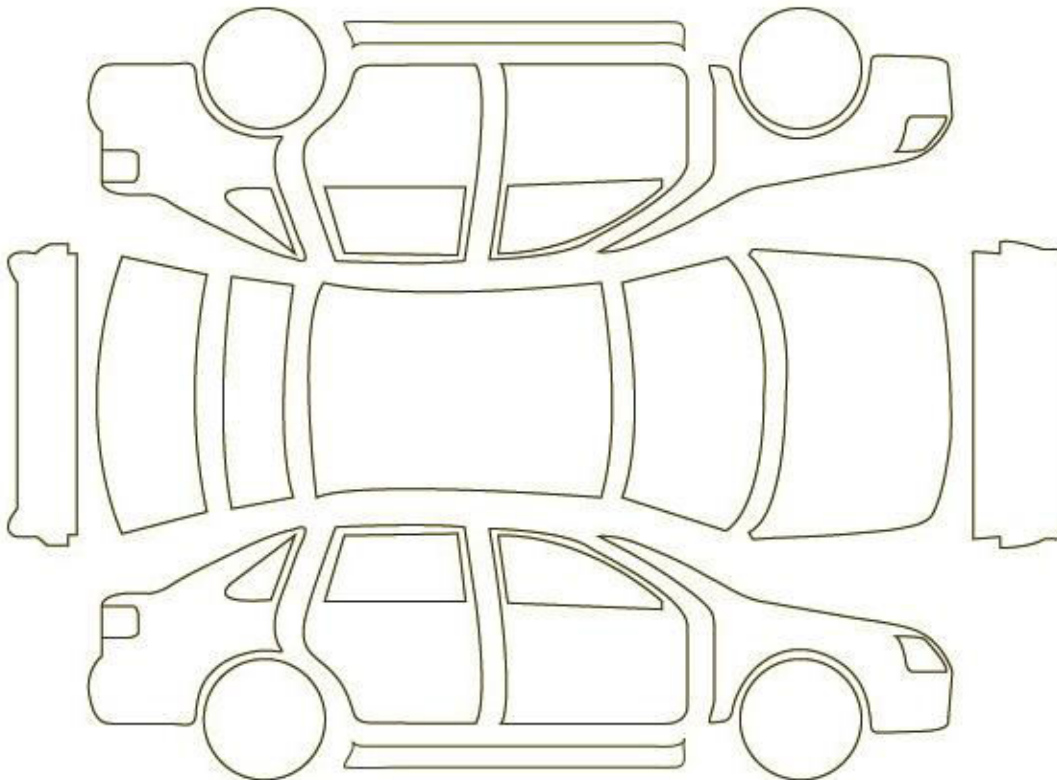
Tyres		
Brand Name		Front Yangon Tyre,Rear Left Good Year, Rear Right Deestone
Tyre Size	13	
Front Right	3	22%Tyre Life Remaining
Front Left	3	22%Tyre Life Remaining
Rear Right	3	22%Tyre Life Remaining
Rear Left	2	6%Tyre Life Remaining
Spare Tyre	OK	
Rims	OK	
Exterior Condition
