<b>Suzuki Ciaz</b>
--------------------

General Information	
<b>Seller Name</b>	Aung Aung Oo
<b>Engine Capacity</b>	1400 CC
<b>Mileage</b>	7890 Km
<b>Fuel Type</b>	Petrol
<b>Transmission Type</b>	Auto
<b>Color</b>	Black
<b>Location</b>	Botahaung

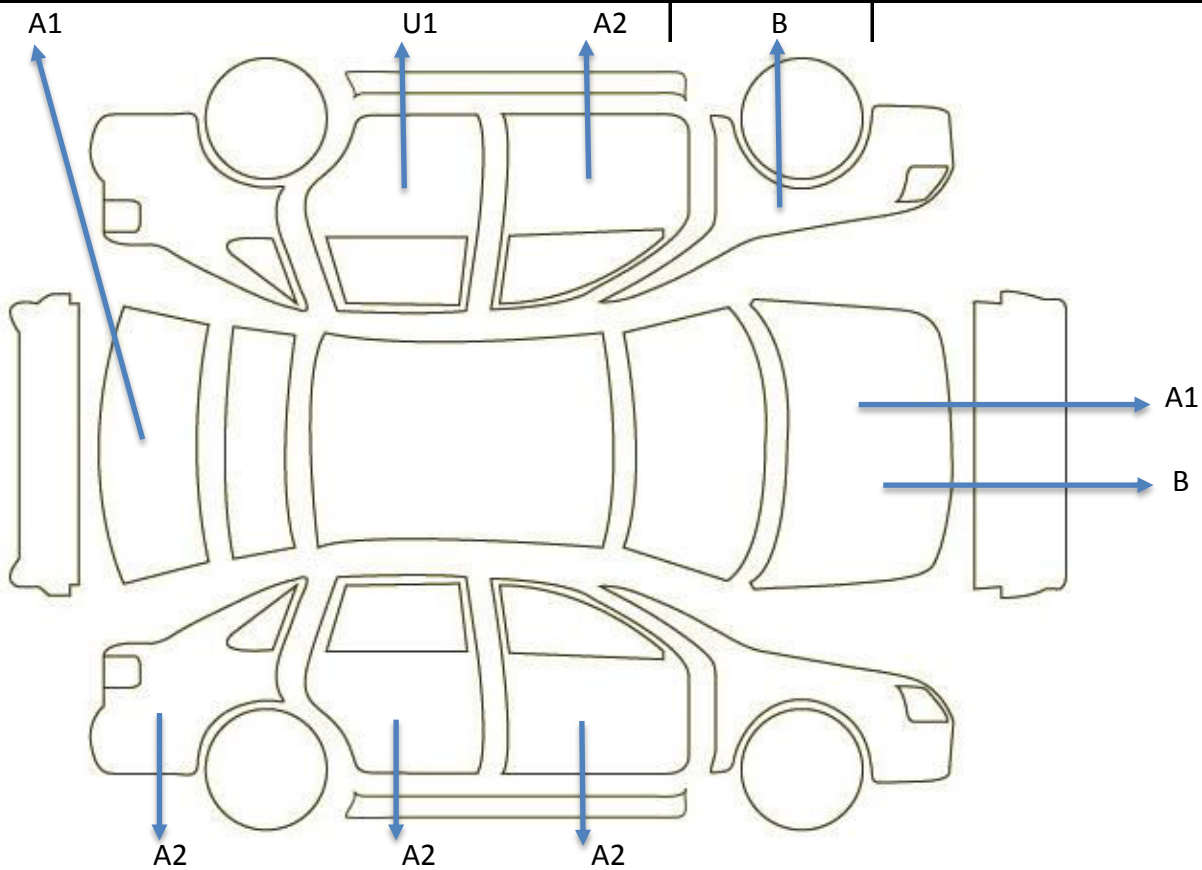
Tyres		
Brand Name	Bridgestone	
Tyre Size	16	
Front Right	6mm	69%Tyre Life Remaining
Front Left	6mm	69%Tyre Life Remaining
Rear Right	6mm	69%Tyre Life Remaining
Rear Left	6mm	69%Tyre Life Remaining
Spare Tyre	OK	
Rims	OK	
Exterior Condition
