Inspection Date: 25.2.2019

Chassis No:MNCLMBF80FW419051

Registration No: 209

FORD RANGER

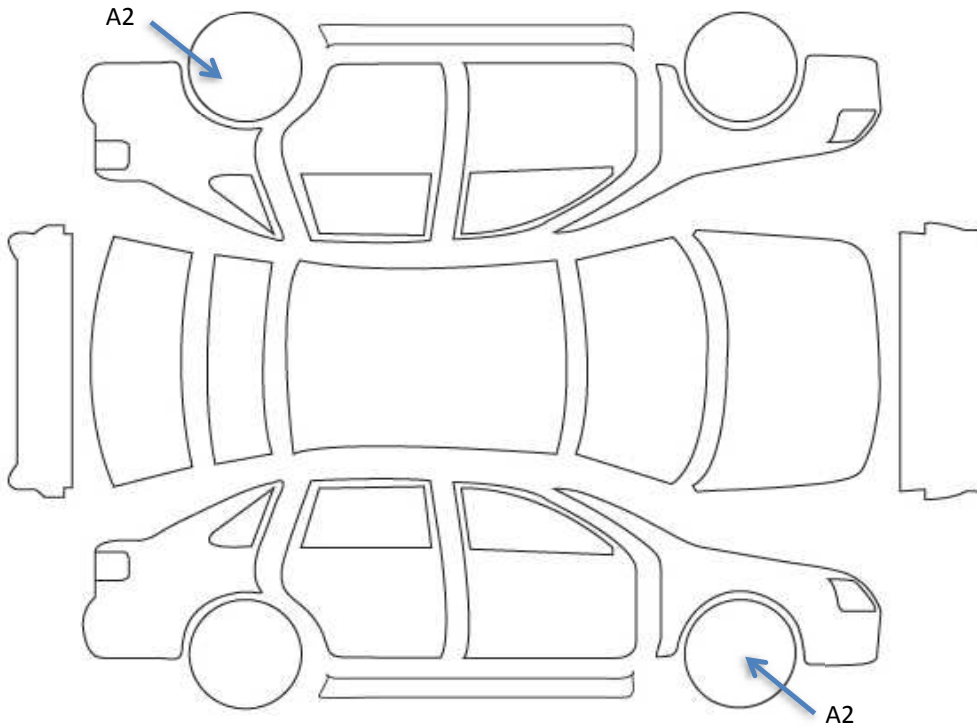
Remarks		
<p style="text-align: center;">စာကြည့်မီးကွဲ ၊ ဘယ်ဘက်လက်ကိုင်ကွင်းကျိုး ၊ Alloy ရှေ့ညာဘက် နောက်ဘယ်ဘက် နည်းနည်းပွန်း ၊ ဘယ်ဘက်ခြမ်းမှန်တင်မှန်ချမရ ။</p>
