Mitsubishi RVR

General Information	
Seller Name	Hein Wunna Hlaing
Engine Capacity	2400 CC
Mileage	76135 Km
Fuel Type	Petro
Transmission Type	Auto
Color	Light Blue
Location	East Dagon

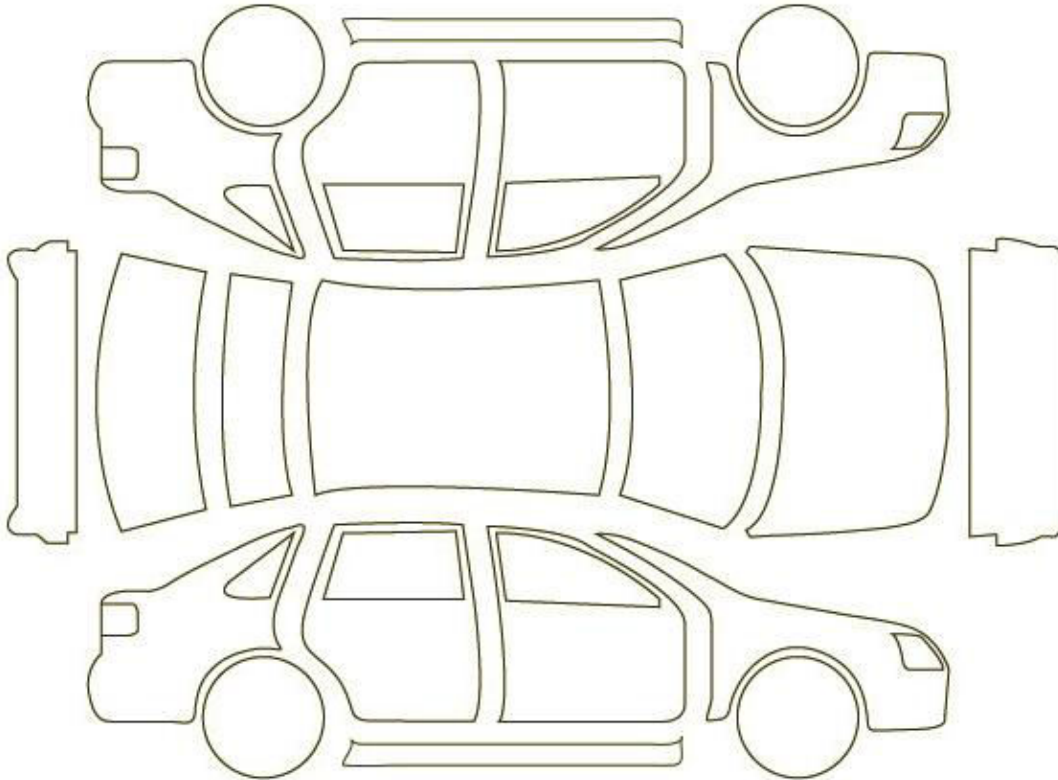
Tyres		
Brand Name	ACCELERA	
Tyre Size	17	
Front Right	2	6% Tyre Life Remaining
Front Left	2	6% Tyre Life Remaining
Rear Right	4	38% Tyre Life Remaining
Rear Left	4	38% Tyre Life Remaining
Spare Tyre	N/A	
Rims	OK	
Exterior Condition
