<b>MG MG6</b>
---------------

General Information	
<b>Seller Name</b>	Aung Aung Oo
<b>Engine Capacity</b>	1800 CC
<b>Mileage</b>	52102 Km
<b>Fuel Type</b>	Petrol
<b>Transmission Type</b>	Auto
<b>Color</b>	Pearl Gold
<b>Location</b>	Sauchaung

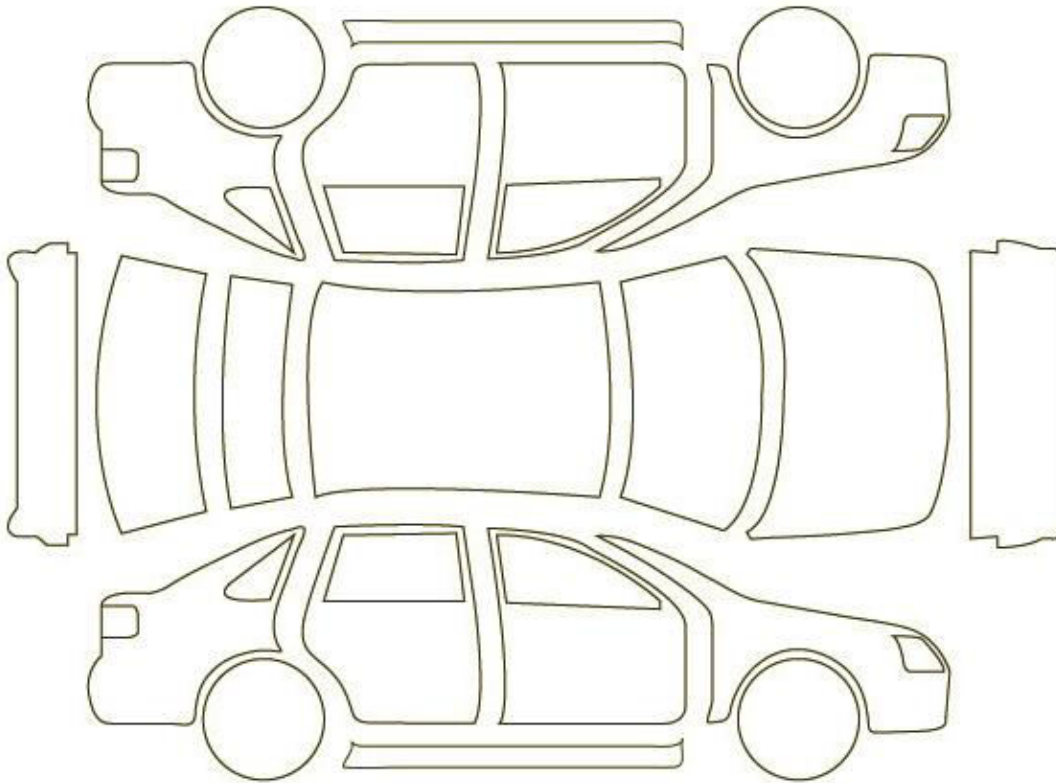
Tyres		
Brand Name	Westlake	
Tyre Size	18	
Front Right	6	69% Tyre life is remaining
Front Left	6	69% Tyre life is remaining
Rear Right	6	69% Tyre life is remaining
Rear Left	6	69% Tyre life is remaining
Spare Tyre	Ok	
Rims	Ok	
Exterior Condition
